# Final Remedial Investigation Report

Williston Local Training Area  
Munitions Response Site, North Dakota

Munitions Response Site NDHQ-008-R-01

August 2019

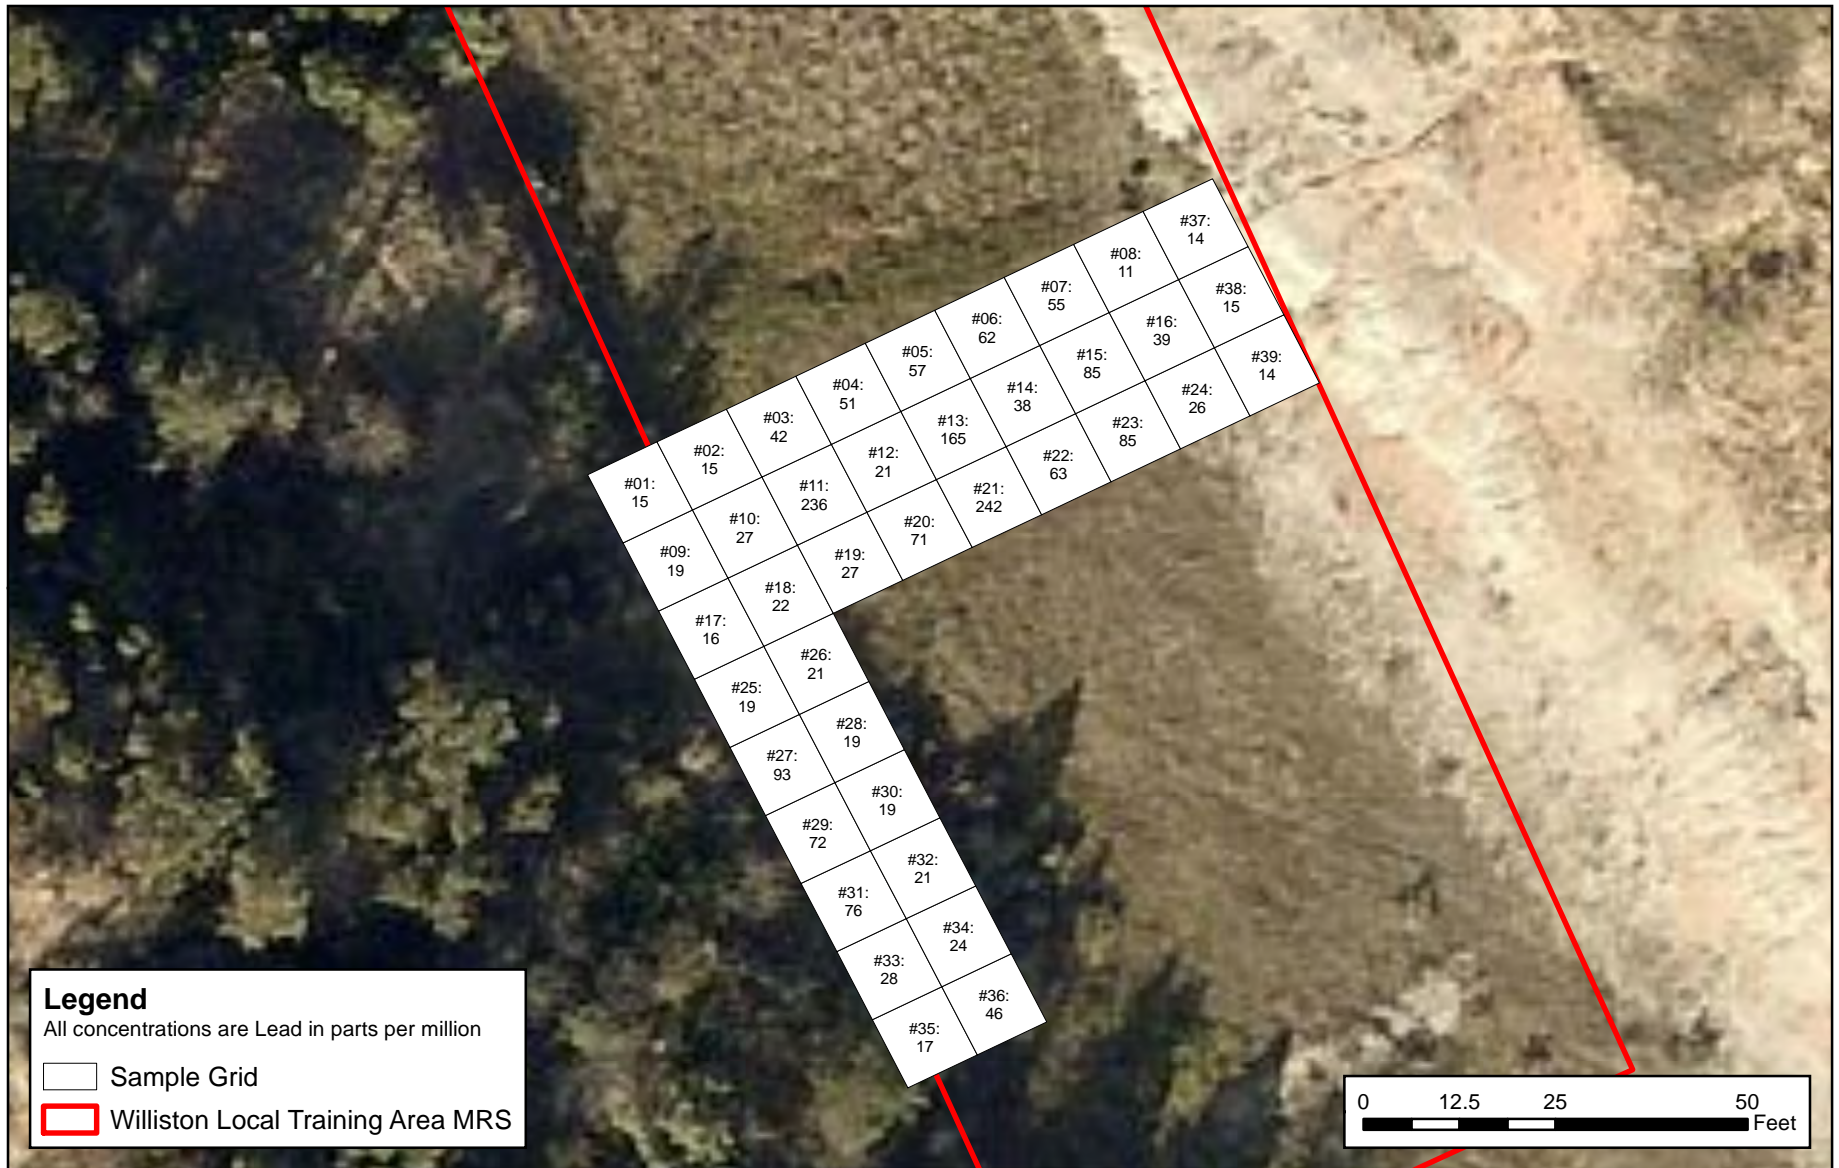
<b>Target Berm XRF Results</b>	
 12420 Milestone Center Drive Germantown, MD 20876	
<b>Figure ES-2</b>

**Legend**  
 All concentrations are Lead in parts per million

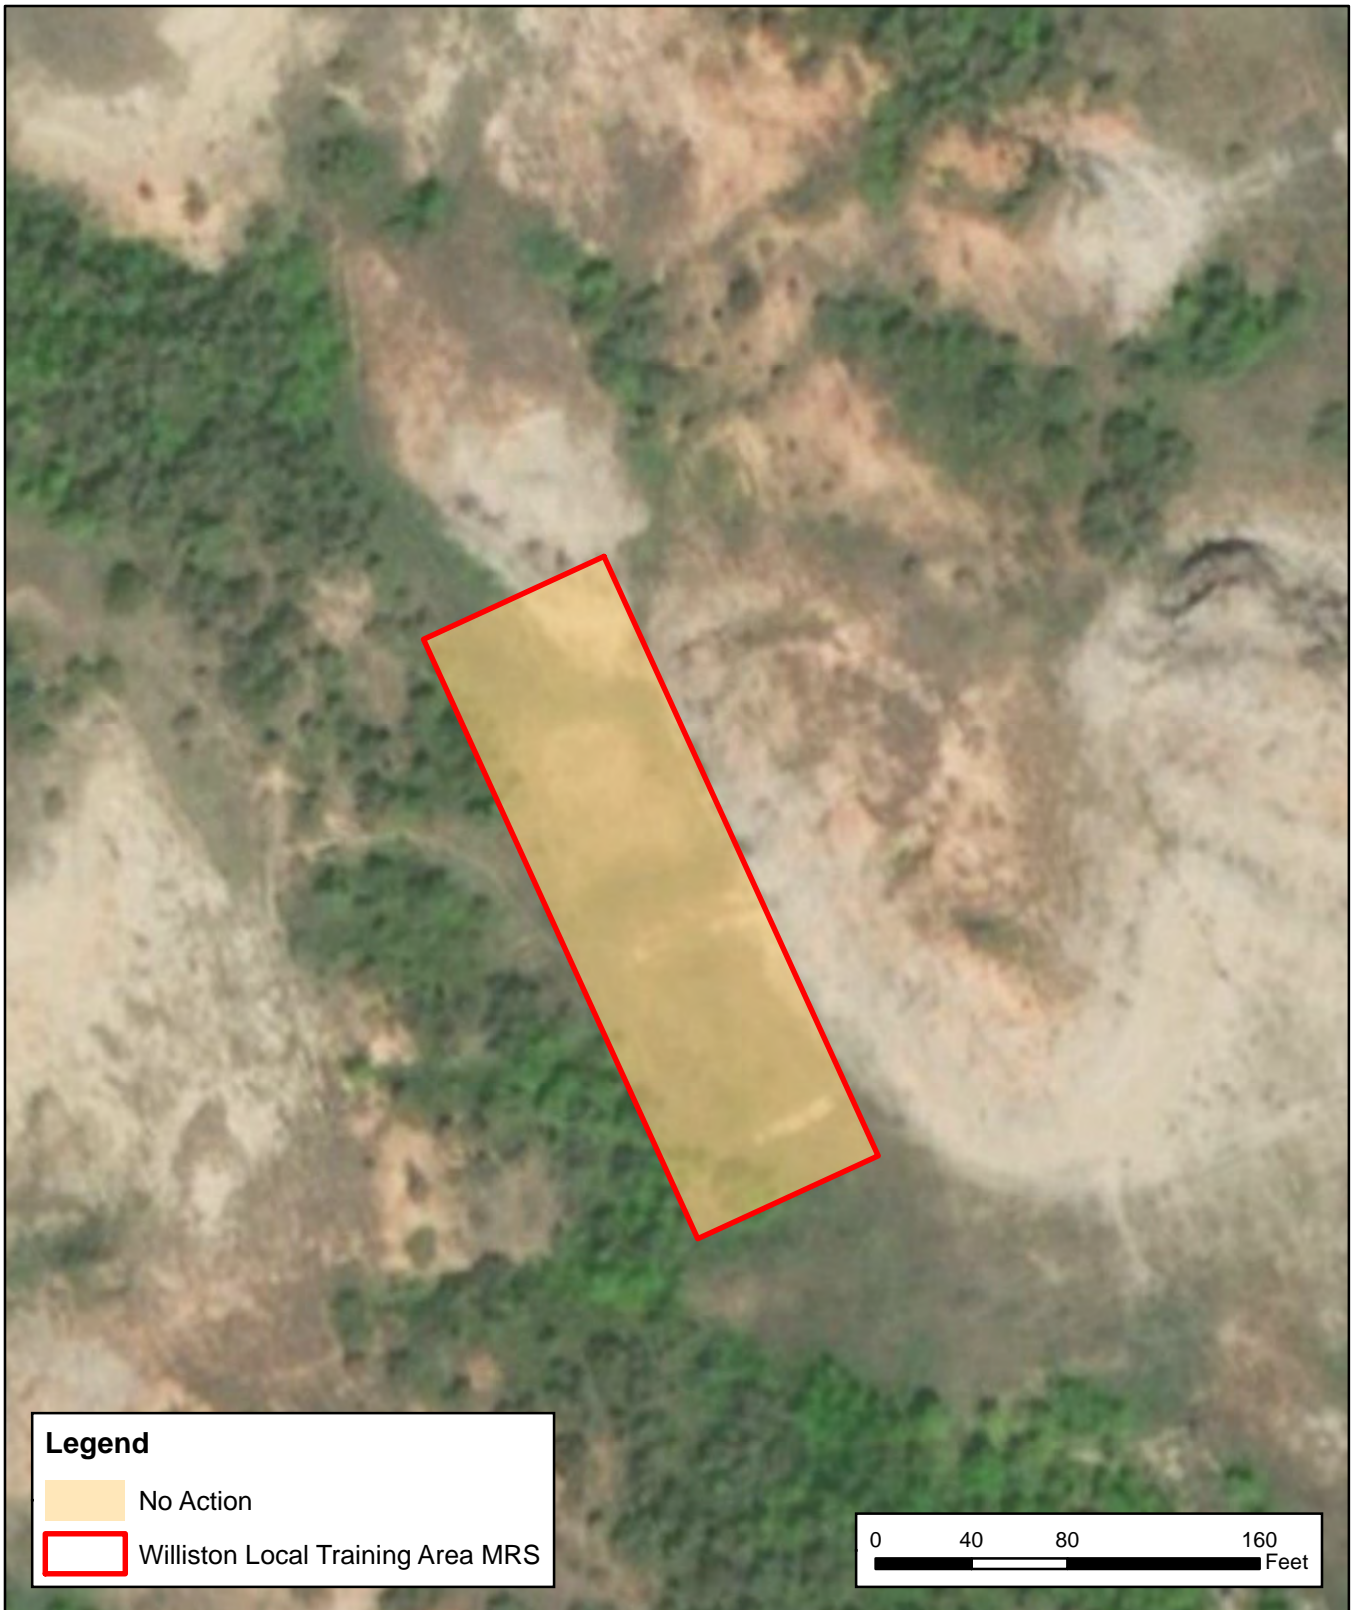
CLIENT		Army National Guard				Proposed MRS Recommendation	
PROJECT		RI through DD for Williston LTA, ND MRS				 	<b>Figure ES-6</b>
REVISION NO	0	GIS BY	MS	11/12/2018			
SCALE	1:960	CHK BY	JL	11/12/2018			
SOURCE	ARNG; State of North Dakota, ESRI & Partners	PM	LS	11/12/2018

Based on the results of the RI, the MRS has been sufficiently characterized. Based on the lack of unacceptable risks, an FS is not warranted at the Williston LTA MRS. No Action is recommended for the entirety of the 0.52-acre MRS (**Figure ES-6**). The next step would be to prepare a proposed plan to convey this finding to the public, followed by a decision document to formally conclude work at the MRS.

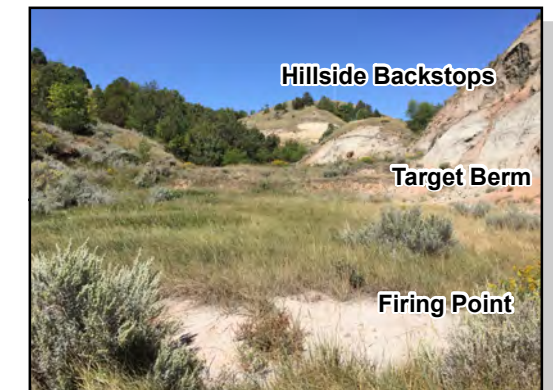
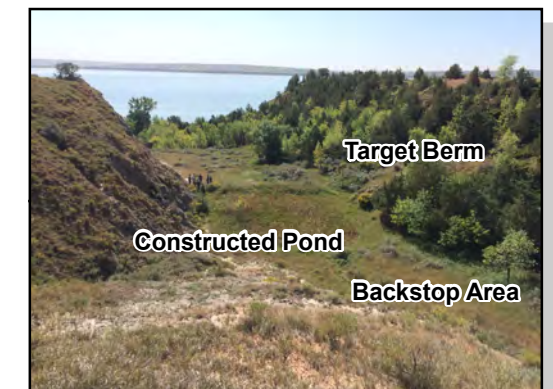
Particulate metals, particularly lead, and bulk bullets/projectiles in soil on the target berm and natural hillside backstops as a result of historical small arms training.

Metals MC have limited potential to migrate from soil at the target berm, or natural hillside backstops (Source areas: “A” on map to left) beyond range boundaries. Due to topography and range orientation, stormwater runoff from hillside backstop areas flows towards the “Dry Pond” impoundment behind the earthen berm. Groundwater at the MRS is approximately 80 feet below ground surface (Cross section A-A’). Groundwater pathways are incomplete since metals are highly unlikely to leach from soil in source areas to deep groundwater. MC within MRS soil is anticipated to collect and remain in the target berm, dry pond and backstop areas, and not migrate off-site. Bulk/coarse bullets are embedded in berm and backstop soil; due to their weight, it is unlikely for them to be transported off-site via overland flow.

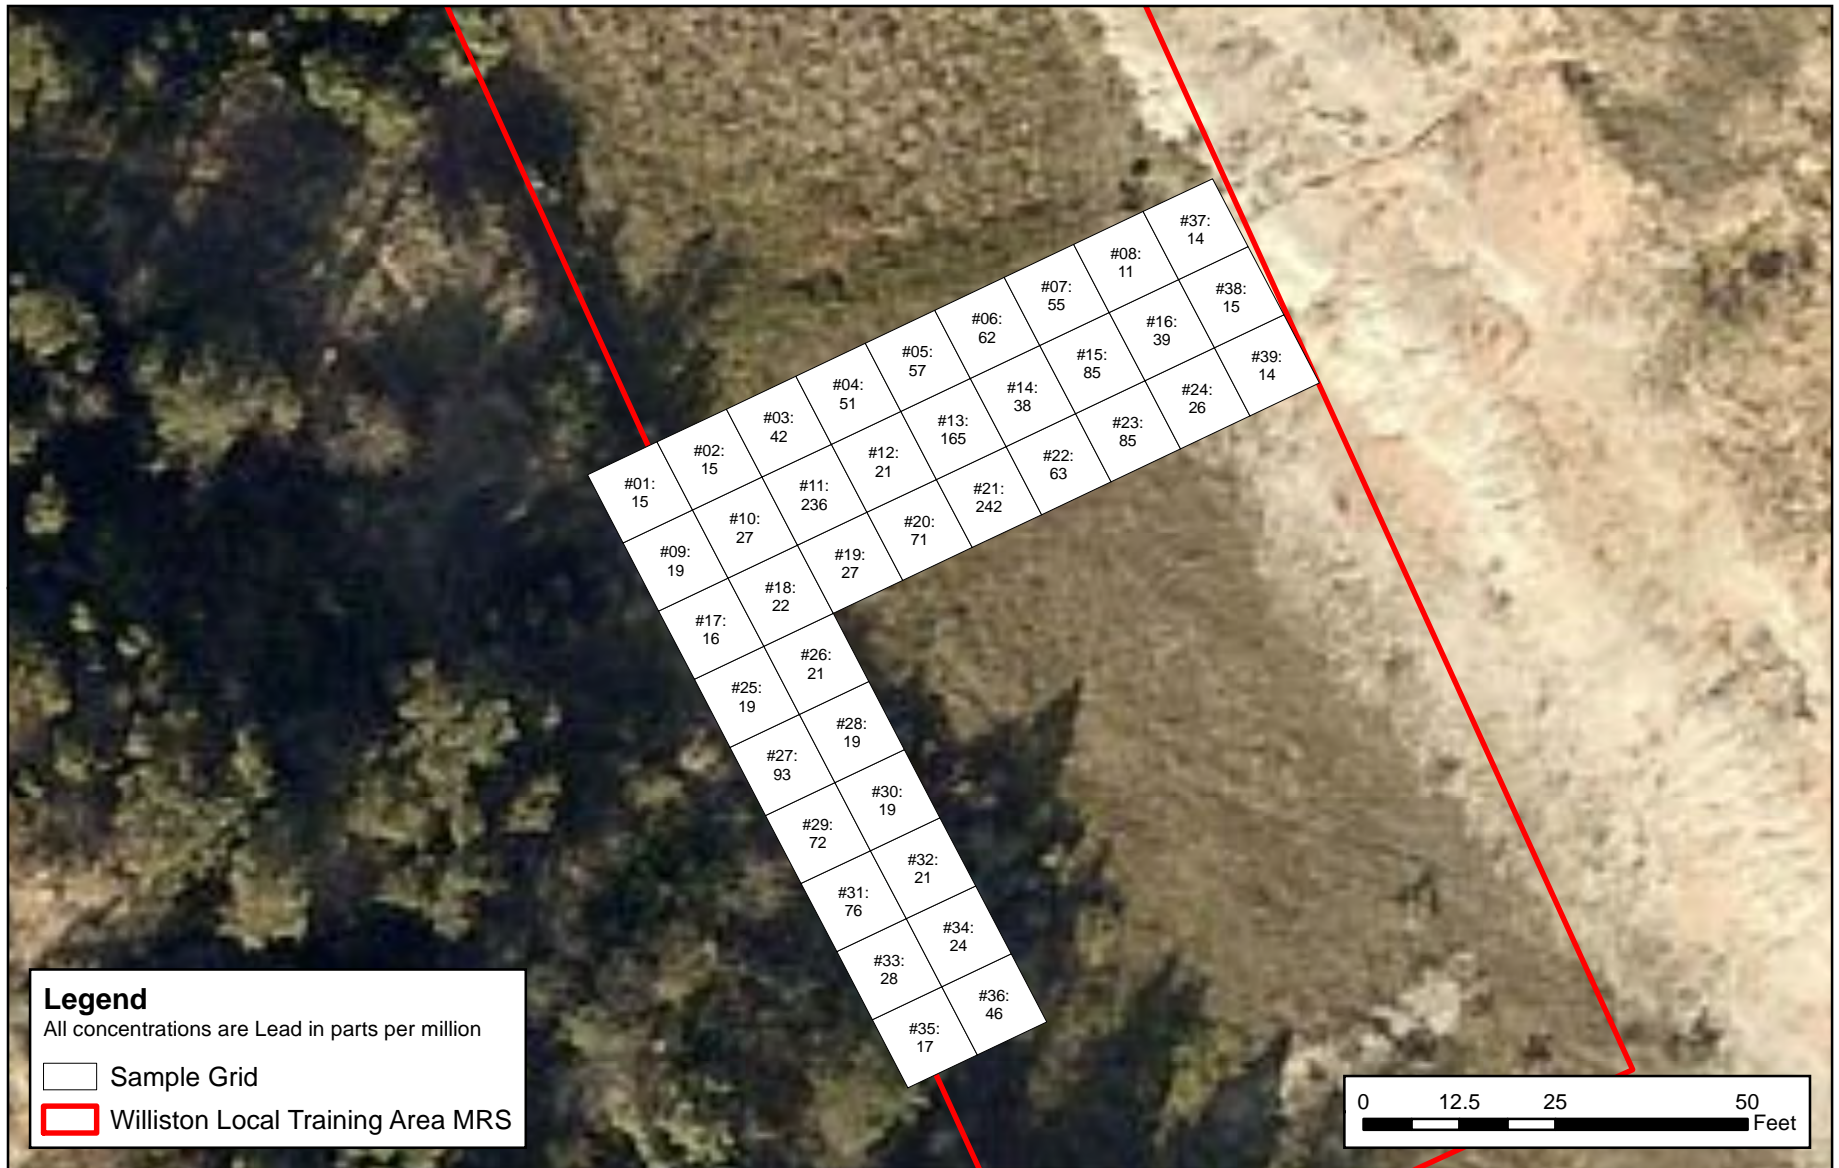
Thirty discrete samples were collected and analyzed for lead by XRF at the Backstop Area. No samples exceeded the human health criterion for lead. Evidence of spent bullets were observed at the base of coulee walls in the Backstop Area; however, no bullets or bullet fragments were observed in XRF samples. Average lead results ranged from 12 ppm at grid #30 to a maximum 119 ppm at grid #18. Refinement of the DU boundary and discrete subsurface soil sampling were not necessary per the UFP-QAPP. The original DU boundary was carried forward for ISM sampling. A summary of discrete XRF lead results is provided in **Table 5-2** and shown in **Figure 5-2**.

**Legend**  
 All concentrations are Lead in parts per million

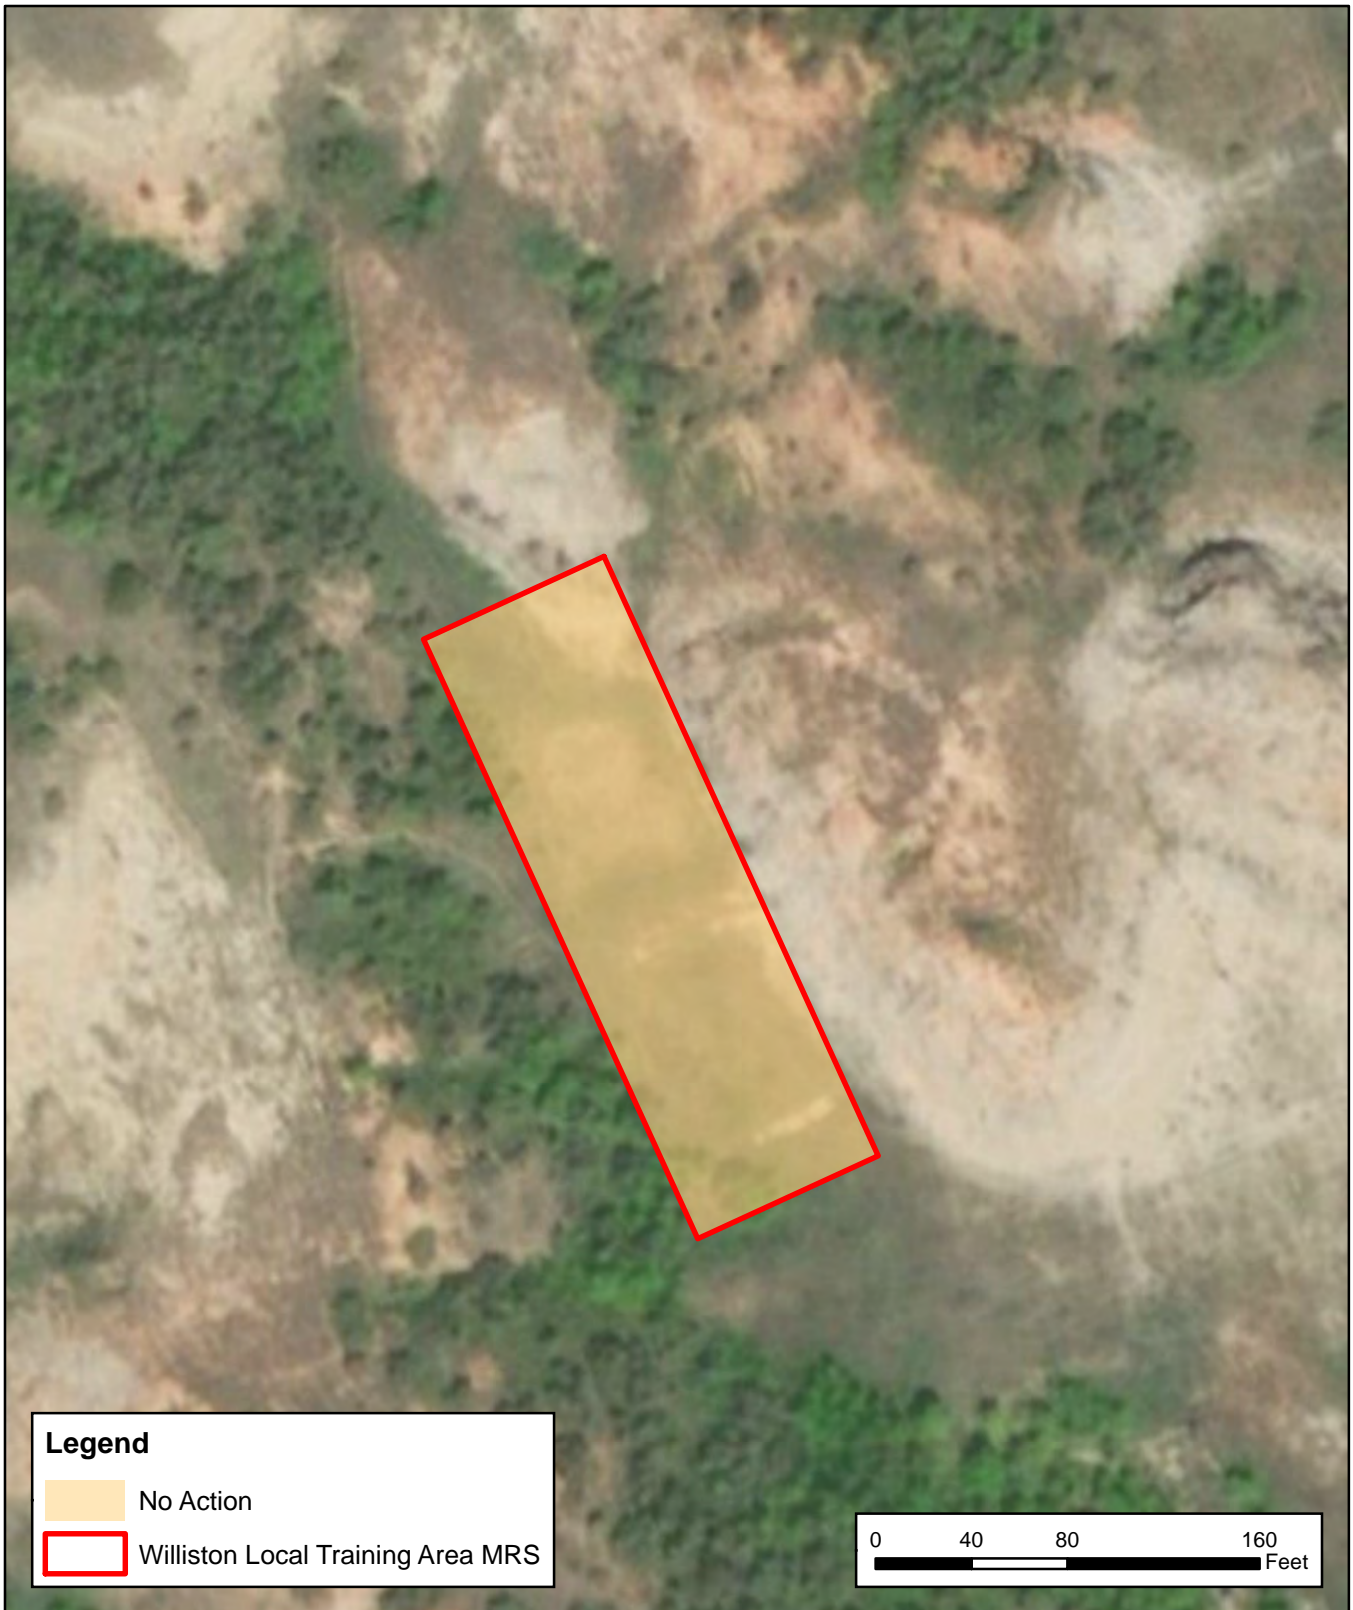
Based on the results of the RI, the MRS has been sufficiently characterized. Based on the lack of unacceptable risks, an FS is not warranted at the Williston LTA MRS. No Action is recommended for the entirety of 0.52-acre MRS (**Figure 9-1**). The next step would be to prepare a proposed plan to convey this finding to the public, followed by a decision document to formally conclude work at the MRS.
